2022 Southeast Afghanistan Earthquake, Rapid Technical Field Assessment Report

Kabul, Afghanistan | Structural Safety Study
August 9, 2022

2022 South East Afghanistan Earthquake Rapid Technical Field Assessment Report

Kabul, Afghanistan | Structural Field Assessment

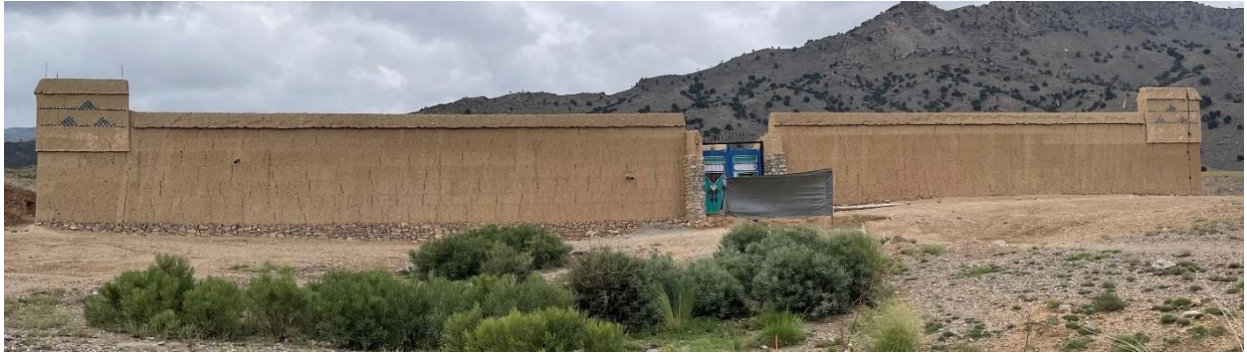
Figure 2-5. Example of a large Pakhsa compound wall (5-6m high).

Pakhsa is a vernacular construction practice that combines regionally available clay soils with small aggregates to form monolithic wall elements. Clay soils are hydrated with water and the batch is worked (mixed) to ensure mixing of the components that are then formed into lifts (layers) of approximately 50cm high. Hydration and batching processes vary based on local cultural practice and potentially related to variations in material quality. New layers are built upon the foundations or underlying supporting course (layer) and later trimmed. These wall systems are most commonly used for perimeter walls, as well as for courtyard-facing exterior room walls, and some interior partition walls. The typical wall height observed for perimeter walls was 3m to 5m (perimeter walls) with interior partition and courtyard facing room walls of 2m to 3m.

In addition to material preparation, material protection from erosion/exposure to water is important to system performance. This is achieved through the use of natural fiber reinforced plaster and/or a capping structure consisting of a sacrificial rounded (or sloped) layer of Paskha over a slate or other material that protrudes from the wall providing a drip line beyond the wall surface. The capping system is easily observed at the top of walls in **Figure 2-5 and 2-6**.

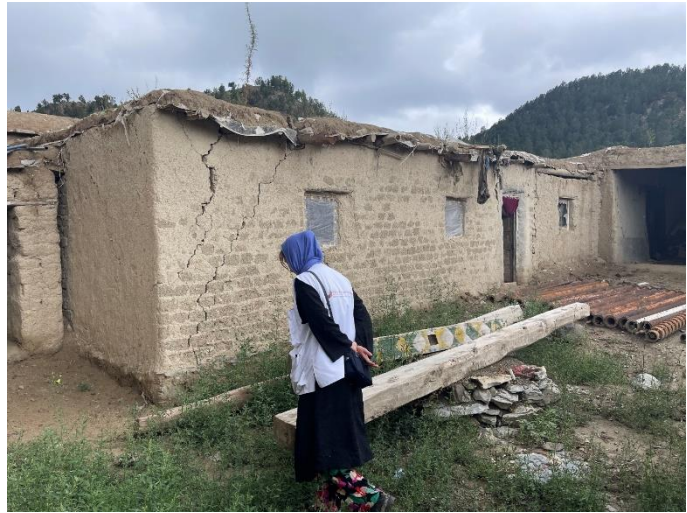
Figure 2-7 Example of mud brick construction.

Mud brick is a vernacular construction practice that combines regionally available clay soils with small aggregate to form regular rectangular block elements. The size of the blocks varies by location as does the composition of the block elements. Like *Pakhsa*, clay soils are hydrated with water and the batch is worked (mixed) to ensure consistency and then formed into the block elements. The bricks are then assembled in courses with differing thicknesses and used to support the roof system. **Figure 2-7** illustrates typical mud brick construction.

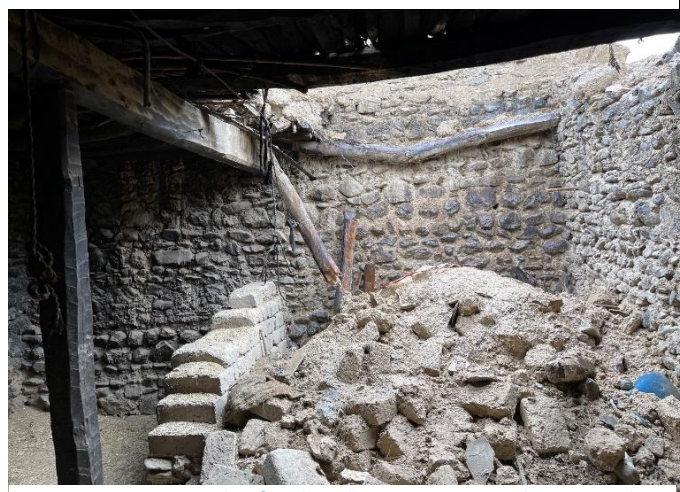
Figure 2-8. Example of rock wall construction to the rear with collapsed mud brick rubble in front.

Figure 2-8 illustrates typical rock wall construction, in this case built with an interlocking clay-based mortar.

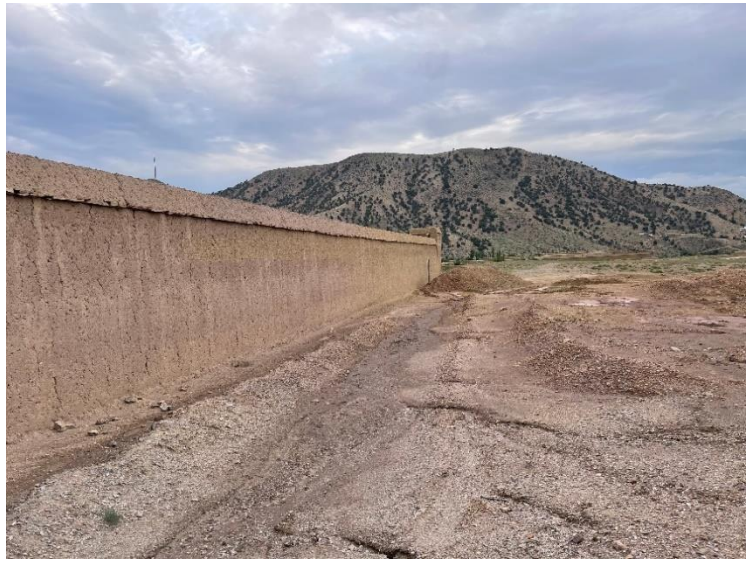
Figure 2-9 Length to height ratio of Pakhsa walls

Commonly in URM buildings the distance between orthogonal walls and the presence of the floor/roof connection makes the structure work as a box like element, when exposed to a seismic event. In those cases, band beams are necessary to connect the floors to the walls and orthogonal walls.

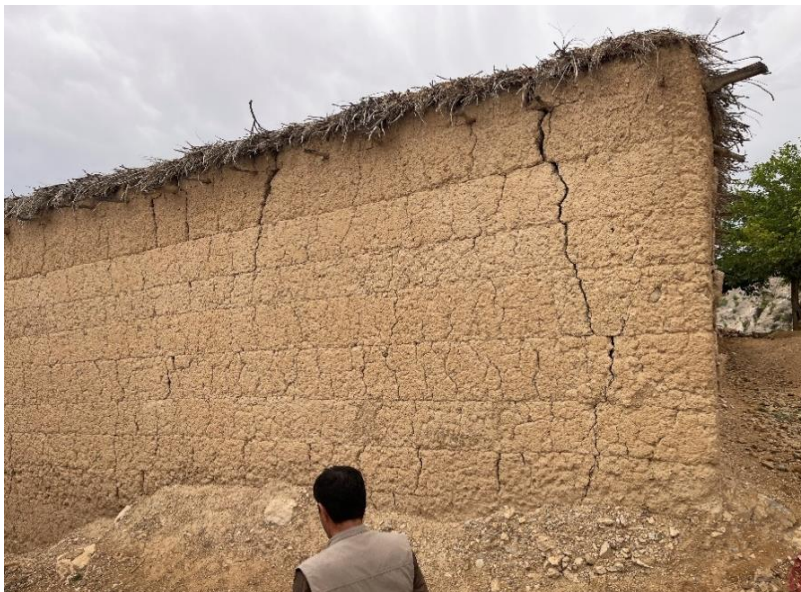
Figure 2-11 Example of commonly observed partial corner detachment.

The shape factor in the *Pakhsa* compound walls produces a different behavior of the wall in the central part and close to the corners. In these last positions the cracks disconnect the two orthogonal walls that displace independently as illustrated in **Figures 2-10 and 2-11**.

The evidence of rocking behavior during earthquakes is the probable reason behind commonly observed detachments at wall corners as seen above. ***In this case a strip band especially of rigid concrete or steel elements may significantly alter this structural behavior increasing the probability of structural instability and potential building failure.***

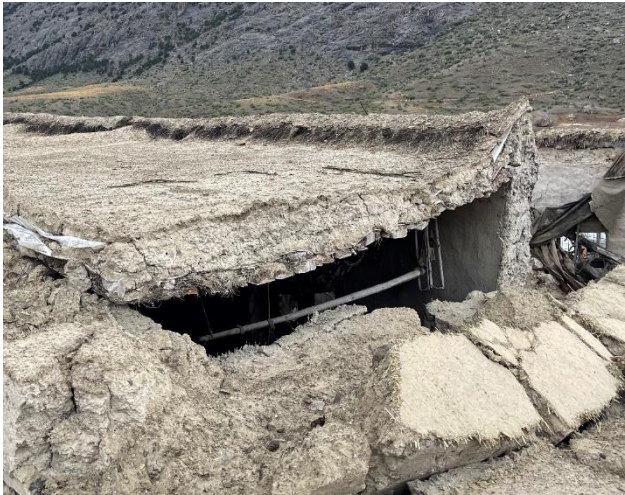
Figure 2-13. Failed section of multilayered roof.

Roofs are commonly repaired prior to winter with additional layers of mud added to ensure adequate waterproofing and improve thermal comfort. Proper maintenance of the roofing systems should include regular removal of excessive mud and replacement of mud/timber where needed to ensure structural quality and adequate water protection. Many cases were observed where multiple layers of mud had accumulated over the years, resulting in excessive roof thickness and potentially unnoticed pest or rot damage to timbers. The weight of the mud roof system, particularly where multiple layers have been allowed to accumulate, contributes significantly to the seismic mass of these structures and is associated with reduced performance. Reference **Figure 2-13**.

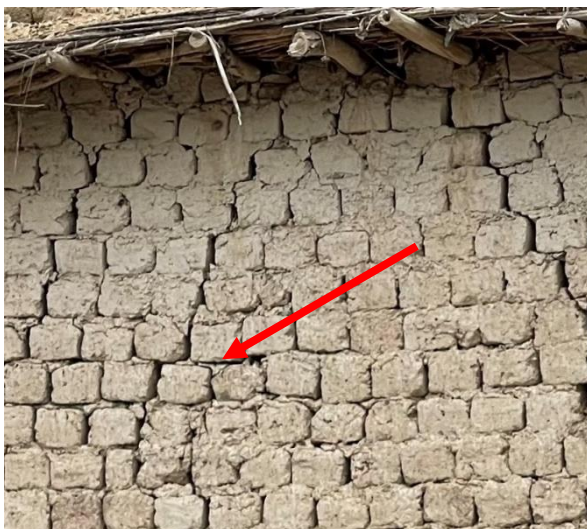
Figure 2-17. Example of insufficient coursing.

In addition to incorrect coursing, **Figure 2-16** illustrates poor mortar joints including incomplete head and bed joints. The head (sometimes referred to as perpendicular joints) refers to the vertical joint between adjacent masonry units. The head joints maintain space between the masonry units and help make the wall act as one. When the head joints are incomplete, it allows masonry units to shift and can lead to an incomplete gravity load path resulting in failure, reference **Figure 2-17**.

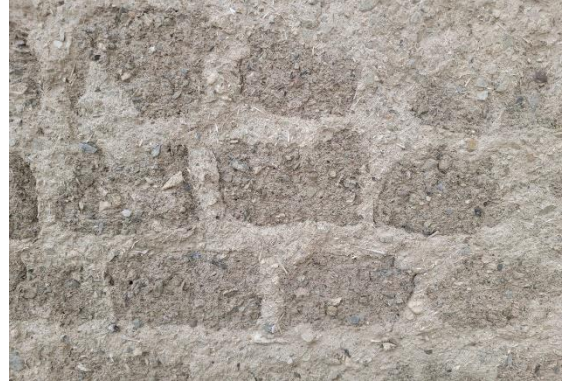
Figure 2-18. Example of plaster protecting mortar.

Due to the small unit nature of the mud brick system, erosion and water protection were noted as critical to performance. When the mud brick system isn't protected from water, the units and mortar were noted to deteriorate with significant structural implications. The traditional solution for this is the application of a mud-based plaster that provides protection. Wall systems with maintained plaster were observed to perform better than those lacking plaster. **Figure 2-18** illustrates plaster wall protection.

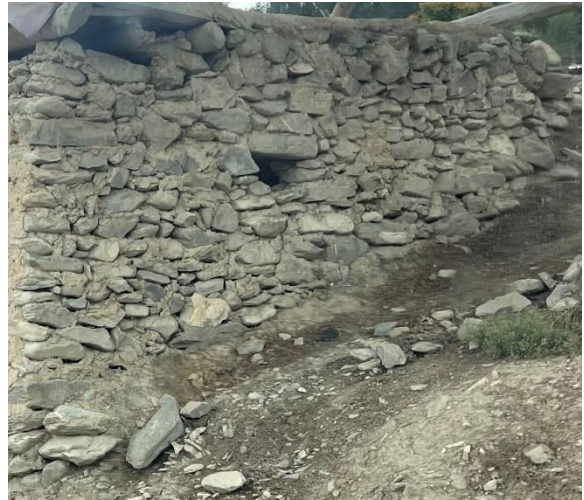
Figure 2-19. Example of angular rock wall construction.

Rock walls utilize locally available rocks and the shape/form of these varies regionally. In some cases, they are round river rocks while in other locations they are flatter and angular. In general, wall systems with angular rocks assembled to provide a cohesive wall and bound by mortar have better performance. **Figure 2-19** illustrates an example of angular rock construction.

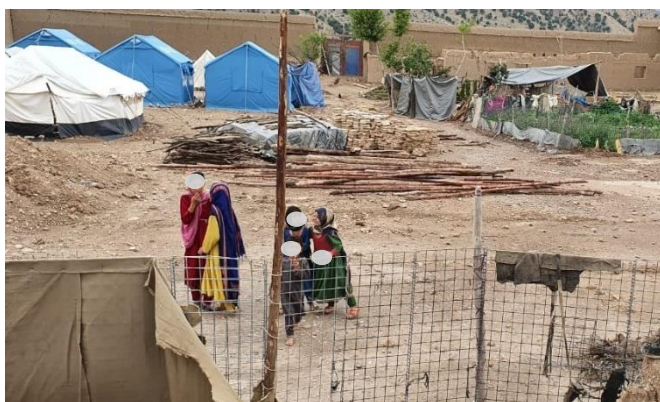
Figure 3-3. View inside a compound, note the repairable rooms to the top right and that women are confined to the tents visible top left.

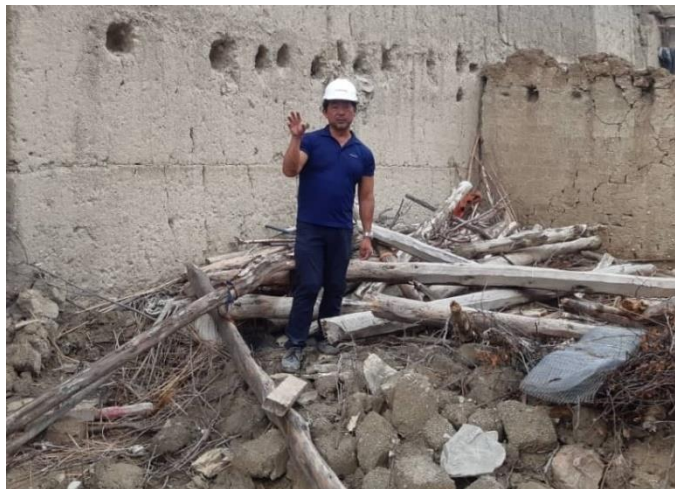
- **Importing of additional timber.** While nearly all sites visited had sufficient timber for the construction of emergency shelters, in some cases this used a significant proportion of the household's salvaged materials, potentially impeding future recovery plans. Supply of some timber may help address this concern and reduce pressure on local deforestation.

Figure 4-2. A high volume of salvageable timber at an assessed site.
